11 EXAMPLE WAY, SCOTLAND, ML2 2IT

4 Bed Detached

Example Homes

Chartered Building Surveyor Best Snag Scotland 14 Jun 2023

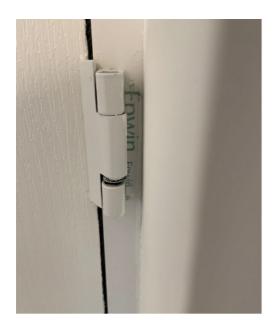
Location: Hall

Description: Front door - hinge cover caps missing

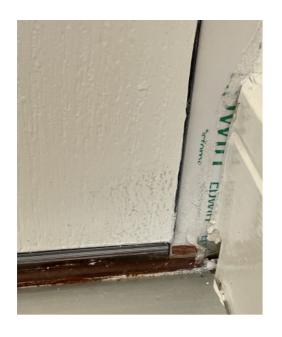
Location: Hall

Description: Front door frame - protection not removed behind hinges

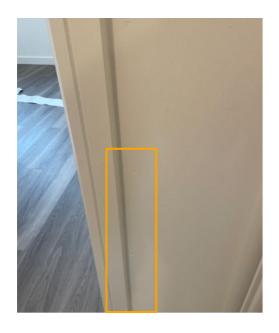
Location: Hall

Description: Kitchen door frame - left hand side, not caulked

Wall - left hand side of kitchen door frame - poor decorative finish

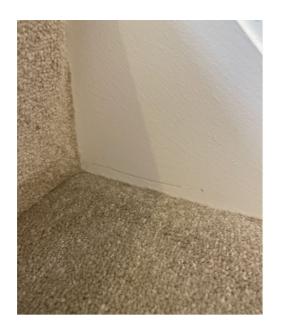
Location: Hall

Wall - right hand side of staircase - plasterboard joints and poor taping evident in 2no. Locations. Description:

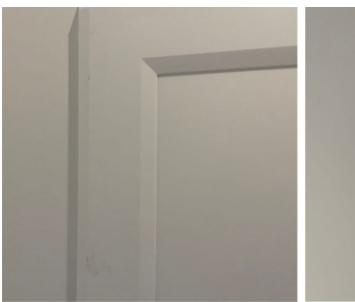
Location: Hall 1st Floor

Description: Wall - above stair opening - plasterboard joint evident

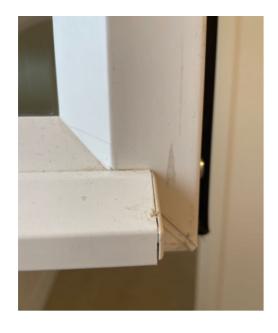
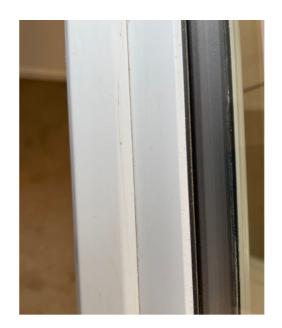
Location: Hall 1st Floor

Description: Window - glass outer pane - scratched as annotated

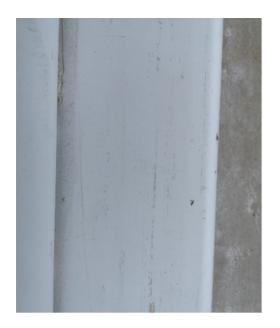
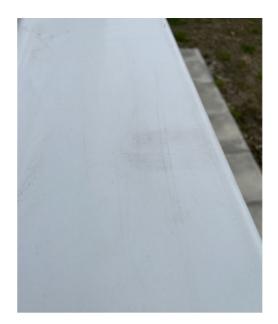
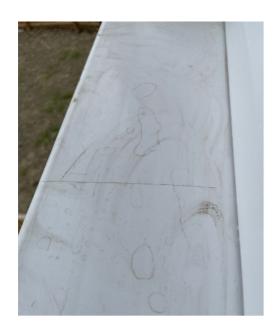
Location: Hall 1st Floor

Description: Window - external pvc frame - dirty and scratched in areas.

Clean and thereafter make good any damage.

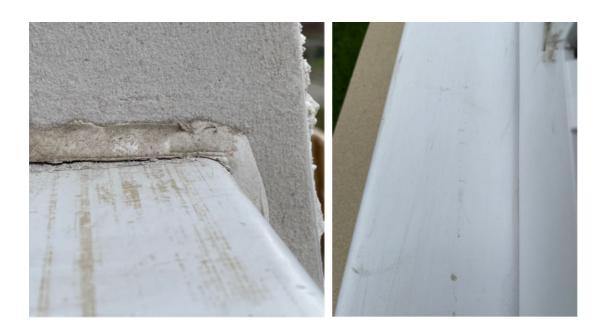
Location: General

Description: Precast window cills - render stained and overspilled.

Professionally clean to remove stains.

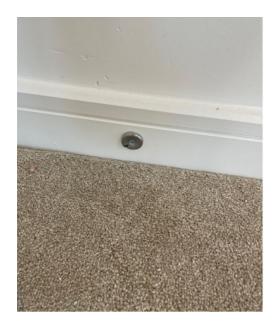
Location: General

Description: Skirtings - review decoration throughout and make good as required.

There are areas where there are a number of paint runs evident, areas that require filling and areas that have been marked by floor fitters/hoovers.

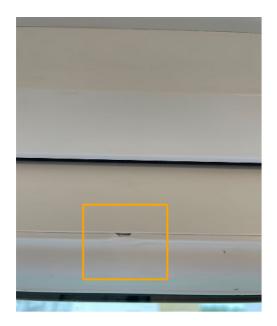
Location: Lounge

Description: Wall - right hand side of front elevation window - plasterboard joint evident

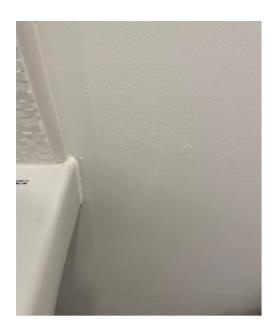
Location: Ground floor w.c

Description: Basin pedestal - not straight

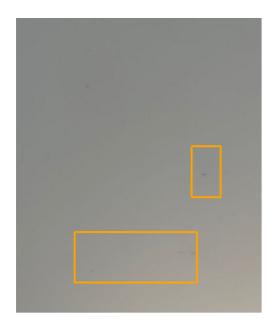
Location: Ground floor w.c

Description: Cistern lid - marked

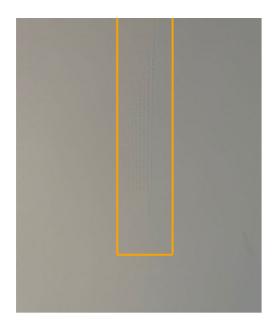
Location: Kitchen/Dining Room

Description: Ceiling - near dining room light pendant - dirty marks adjacent in a number of places.

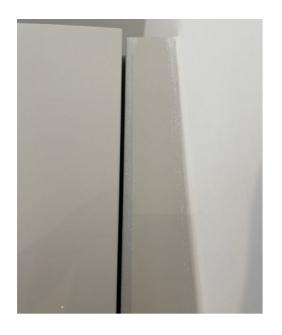
Location: Kitchen/Dining Room

Description: Freezer door - catching infill when opening and closing

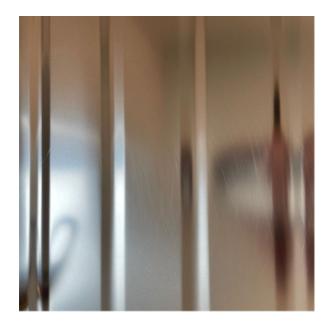
Location: Utility

Description: Window - external glass pane - number of large scratches evident

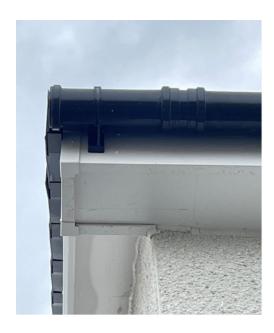
Location: General

Description: General - fascia's and soffits - dirty and stained in a number of areas.

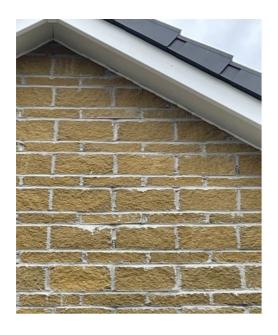
Location: Front elevation

Description: Soffit - left hand side of elevation - scratched

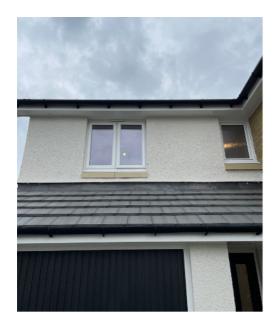
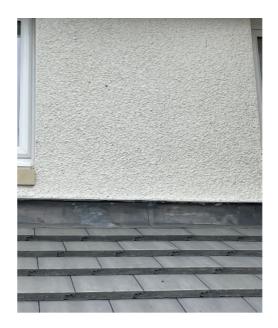
Location: Front elevation

Description: Excess protection to be removed below belcast bead

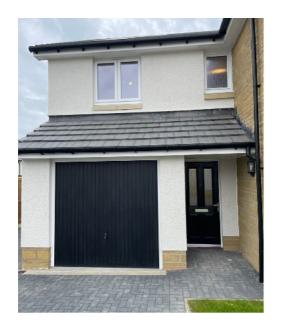
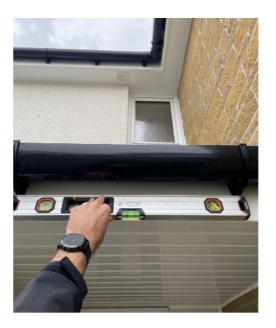
Location: Front elevation

Description: Weep vents at base of render missing to lead cavity tray
