11 EXAMPLE WAY, SCOTLAND, ML2 2IT

4 Bed Detached

Example Homes

Chartered Building Surveyor Best Snag Scotland 14 Jun 2023

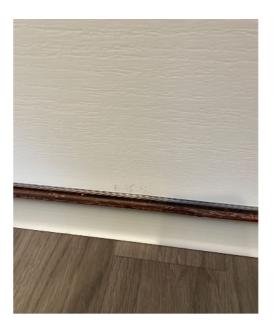
Location: Hall

Description: Front door - poor decorative finish to low level

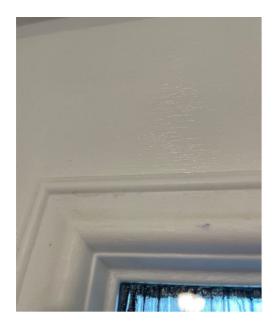
Location: Hall

Description: Front door - left hand side glazing bead- poor decorative finish to head

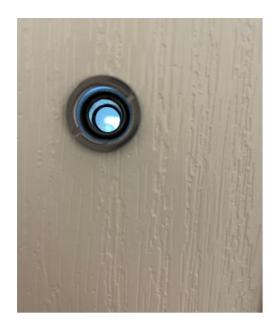
Location: Hall

Description: Front door spyhole - glass scratched, evident when looking through.

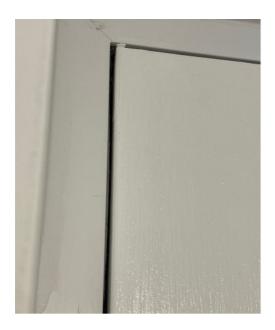
Location: Hall

Description: Door - not sitting flush in head of frame.

Adjustment required

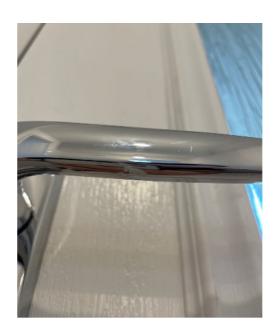
Location: Hall

Description: Front door handle - paint overspilled

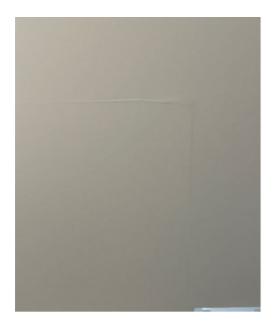
Location: Hall

Description: Ceiling - adjacent stair opening - plasterboard joints evident.

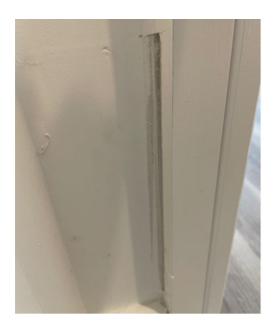
Location: Hall

Description: Kitchen door frame - left hand side, not caulked

Wall - left hand side of kitchen door frame - poor decorative finish

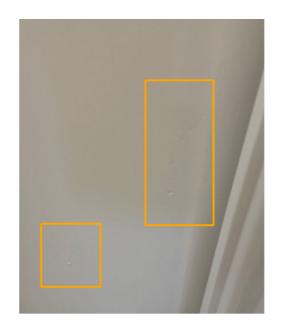
Location: Hall

Description: Walls - right hand side of kitchen door frame, low level - poor decorative finish

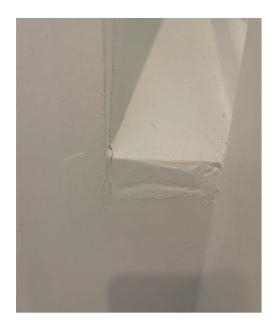
Location: Hall

Description: Wall - left hand side of newel post - poor decorative finish

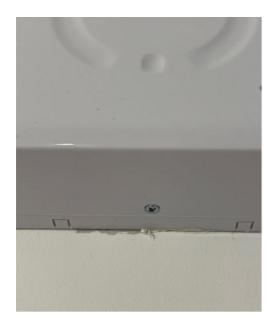
Location: Hall

Description: Wall - below door bell chime- poor decorative finish

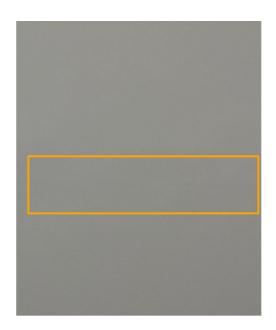
Location: Hall

Wall - right hand side of staircase - plasterboard joints and poor taping evident in 2no. Locations. Description:

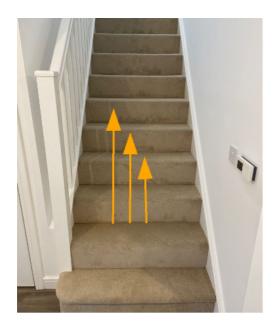
Location: Hall

Description: Stairs - movement underfoot when transversing stair and loud creaking noise evident.

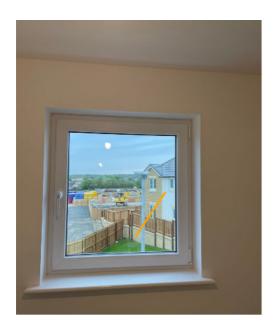
Location: Hall 1st Floor

Description: Window - glass outer pane - scratched as annotated

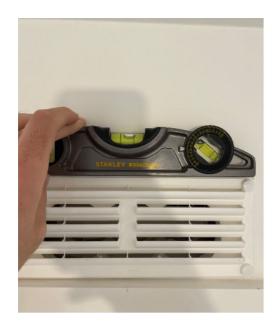
Location: Hall 1st Floor

Description: Cylinder cupboard vent - not level

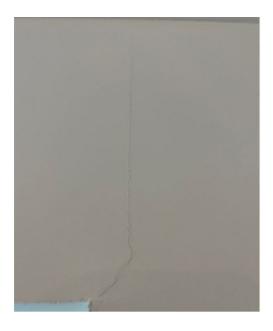
Location: Lounge

Description: Wall - right hand side of front elevation window - plasterboard joint evident

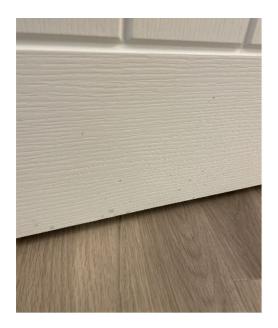
Location: Lounge

Description: Door - poor decorative finish to low level

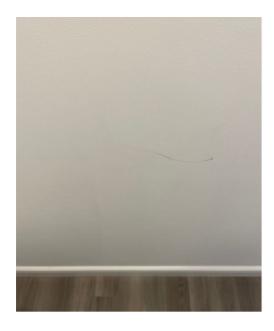
Location: Ground floor w.c

Description: Wall - backing onto staircase - poor decorative finish

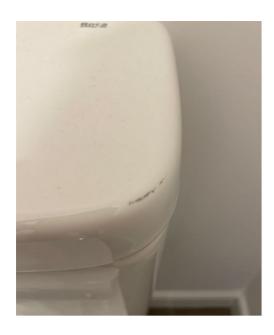
Location: Ground floor w.c

Description: Cistern lid - marked

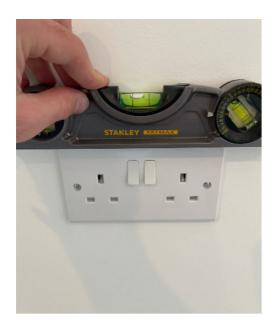
Location: Kitchen/Dining Room

Description: Double socket - left hand side of patio doors - not level

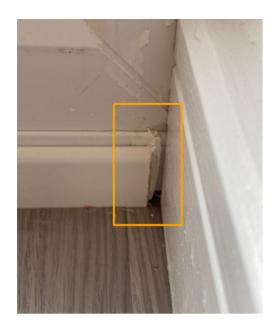
Location: Kitchen/Dining Room

Description: Pvc plate to base of patio doors - cut short on one side.

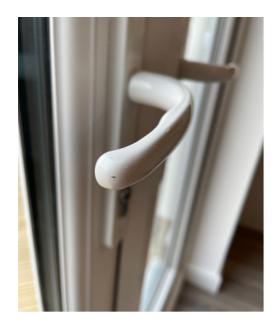
Location: Kitchen/Dining Room

Description: Left hand side patio door handle - finish chipped

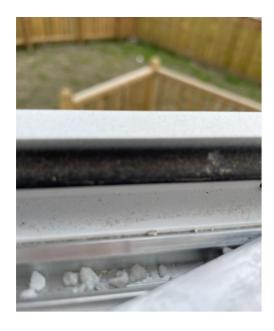
Kitchen/Dining Room Location:

Left hand side patio door - clean roughcast aggregate out head of door. This is affecting the operation of the restrictor. Description:

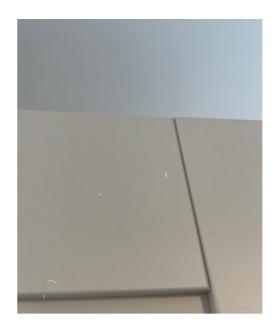
Location: Kitchen/Dining Room

Description: Wall units - left hand side of window - paint overspilled

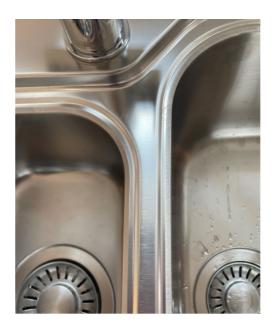
Location: Kitchen/Dining Room

Description: Sink and draining board - finish scratched

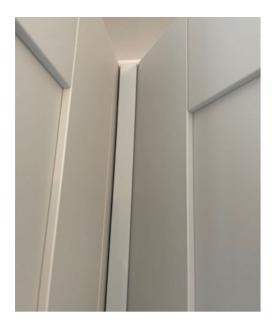
Location: Kitchen/Dining Room

Description: Wall unit door - left hand side of extract fan - catching infill when opening and closing

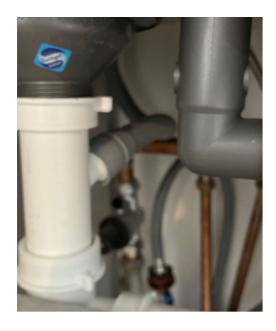
Location: Kitchen/Dining Room

Description: Dishwasher waste connection - No jubilee clip fitted

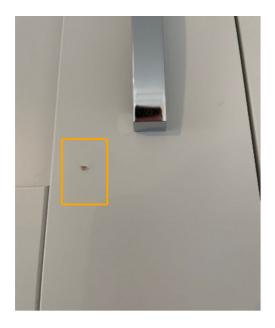
Location: Kitchen/Dining Room

Description: Door above oven - finish chipped

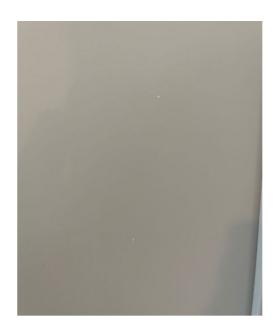
Location: Kitchen/Dining Room

Description: Fridge door and infill panel to right hand side - paint overspilled.

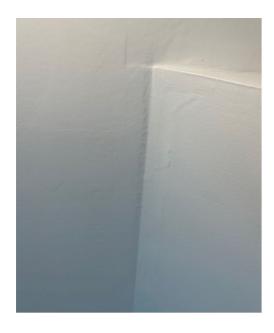
Location: Utility

Description: Coomb below stair - poor decorative finish

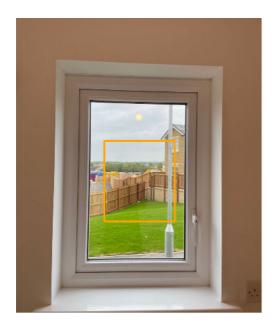
Location: Utility

Description: Window - external glass pane - number of large scratches evident

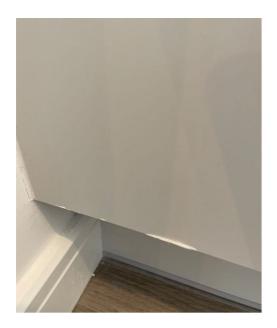
Location: Utility

Description: Left hand side infill panel - chipped along base.

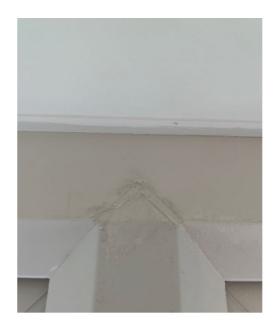
Location: Bed 1

Description: Window - dirty and paint overspilled

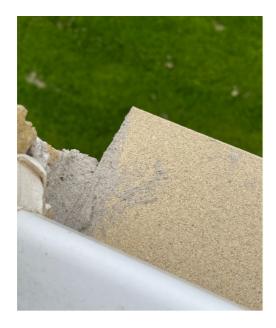
Location: Bed 1

Description: Precast window cill - remove excess mortar

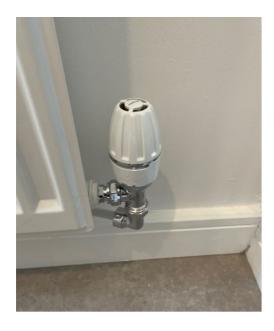
Location: En-suite

Description: Radiator - TRV - not fitted correct way round

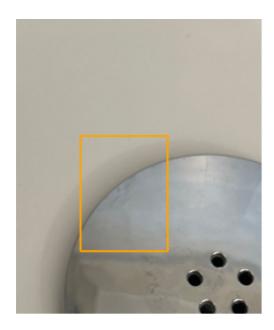
Location: En-suite

Description: Shower waste cap - scratched

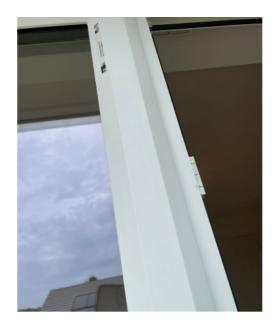
Location: Bed 4

Description: Window - protection and stickers not fully removed

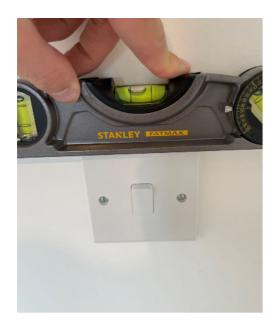
Location: Bed 4

Description: Light switch - not level

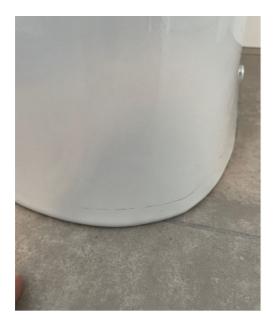
Location: Bathroom

Description: W.C. - finish scratched at base

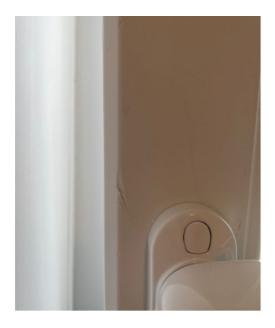
Location: Bathroom

Description: Window - pvc left hand side of handle - chipped

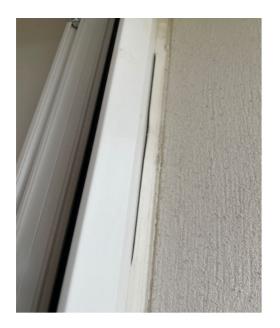
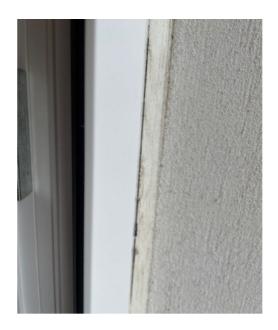
Location: Bathroom

Description: Window - both sides of frame - silicone de-bonding

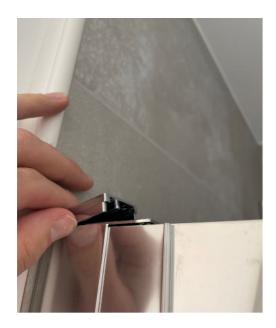
Location: Bathroom

Description: Shower screen cover caps - not secure

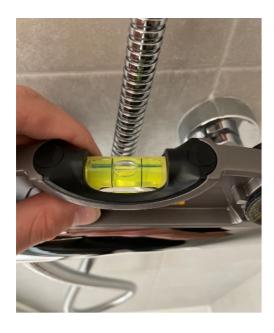
Location: Bathroom

Description: Shower valves - not level

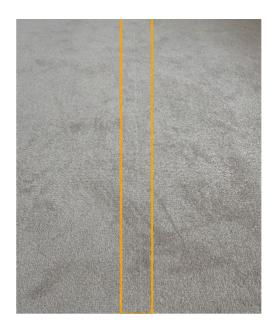
Location: Bed 2

$\label{lem:carpet} \textit{Carpet - appears flawed, 2no. seams evident. Carpet supplier to inspect and rectify or replace if required.}$ Description:

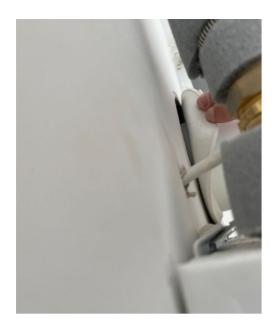
Location: Garage

Description: Boiler flue penetration - not sealed

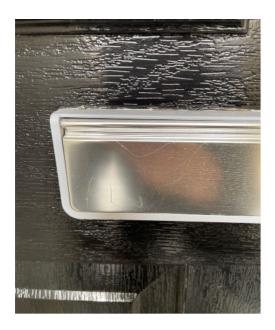
Location: Front elevation

Description: Letterbox - scratched

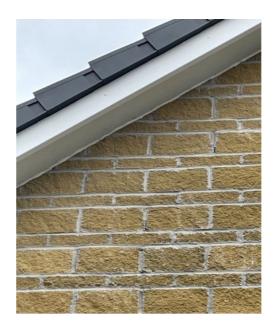
General Location:

Masonry pointing- pointing from 1st floor level to pine level is poor. There is excess mortar on masonry and numerous snots. The pointing is to be rectified to match the quality of the pointing at ground floor level. Description:

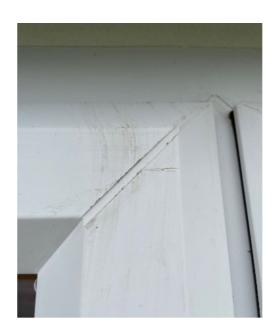
Location: Front elevation

Lounge window frames - dirty, marked and scratched in areas. Clean and thereafter make good any damage. \\ Description:

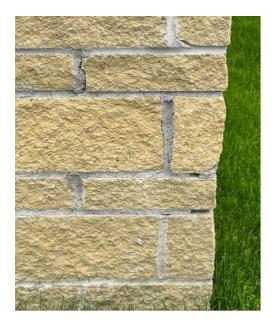
Location: Front elevation

Description: Masonry pointing - right hand side of elevation - localised holes

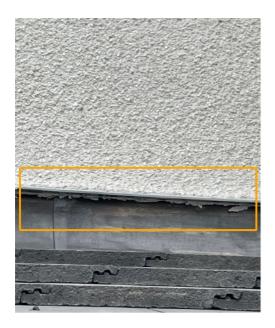
Location: Front elevation

Description: Excess protection to be removed below belcast bead

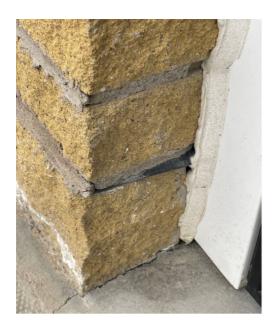
Location: Front elevation

Description: Masonry - left hand side of garage door - dpc exposed

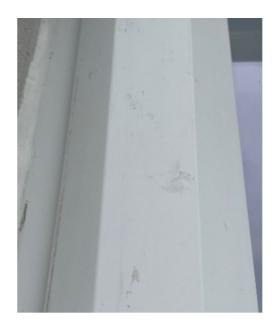
Location: General

General - external windows and frames - pvc is marked, dirty and scratched in areas. Clean all and thereafter make good any damage. Description:

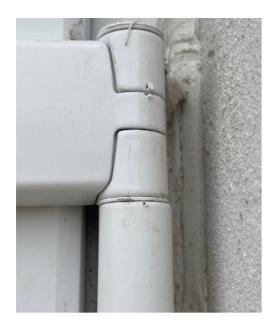
Location: Rear elevation

Description: Patio door hinges - mortar overspilled

Patio door hinge - top right hand side - finish chipped

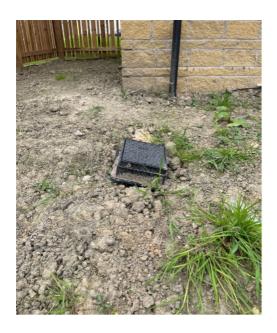
Location: Rear grounds

Description: Rodding point - not level with ground

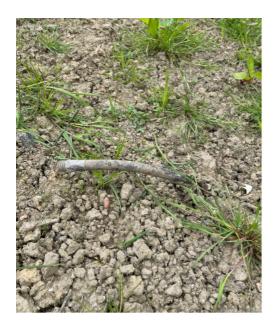
Location: Rear grounds

Description: Soil - remove rod

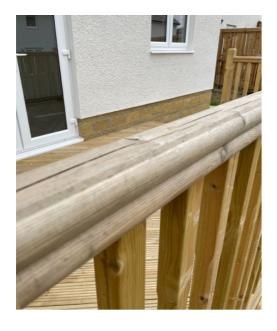
Location: Decking

Description: Decking handrail - localised section has split

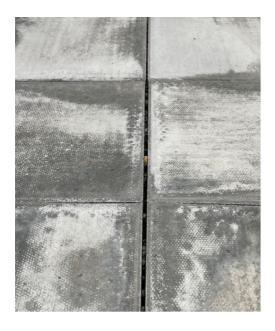
Location: Side grounds

Description: Patch - excessive gaps between paving slabs

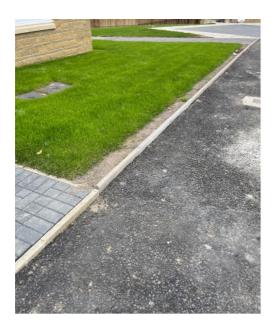
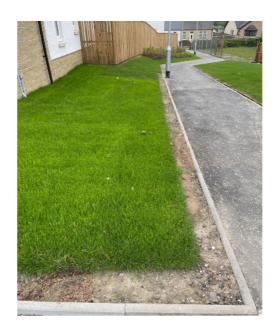
Location: Front grounds

Description: Landscaping - perimeter hedge still to be planted
